ARCHITECT'S FIELD REPORT

PROJECT: Salem Elementary School Renovations

Punch List

ARCHITECT'S PROJECT NO 11.093

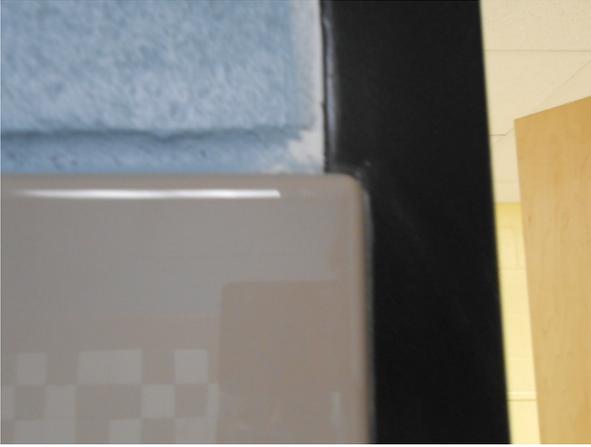
Photo #1

- Clean hand prints and remove stickers from windows as required.
- In All Toilet Rooms, Lockers & Bathrooms:
 1. Re-tile short walls where tile is installed over the door frame. (See photo #1)

- Re-tile West wall to remove ceramic tile from door frame.
- Ease the sharp edges on wall mounted fin tube covers.

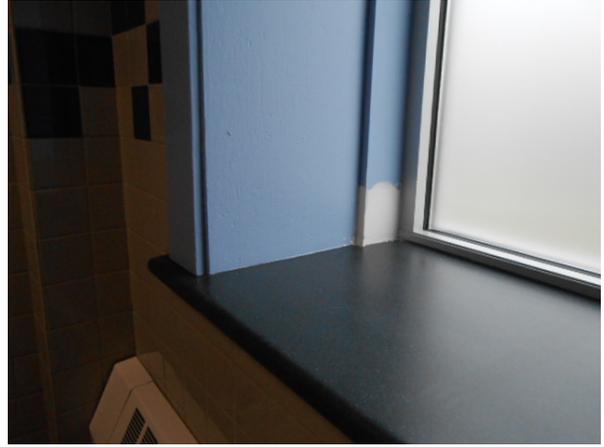
Photo #2

- Re-grout ceramic wall tile to Owners satisfaction.
- General touch up of wall paint. Holidays on both sides of window. (See photo# 2)
- Install missing ceiling tiles.
- Paint exposed wood below window sill to match sill color.
- South West wall corner in toilet stall needs to be caulked.
- Label electrical panels and title each breaker inside to corresponding building locations.

- Re-grout ceramic wall tile to Owners satisfaction.
- General touch up of wall paint. Holidays on both sides of window. (See photo# 2)
- Paint exposed wood below window sill to match sill color.

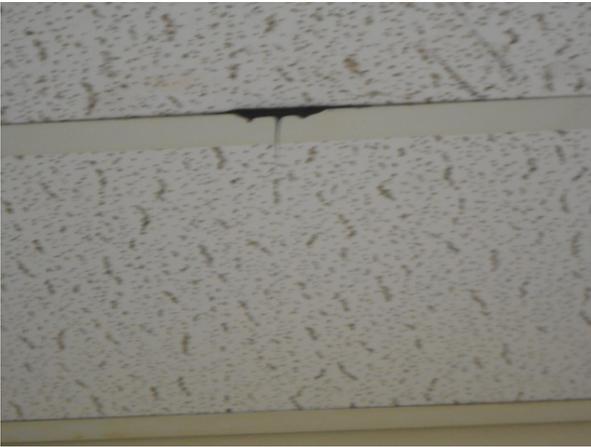
Photo #3

- General clean up.
- Seal areas where day light can be seen around RTU from the closet below in Classroom 138.
- Seal areas where day light can be seen around RTU from the closet below in Classroom 118.
- Verify with Custodial staff the location of the 2 remaining locations with tar on ceiling. (See photo#3)

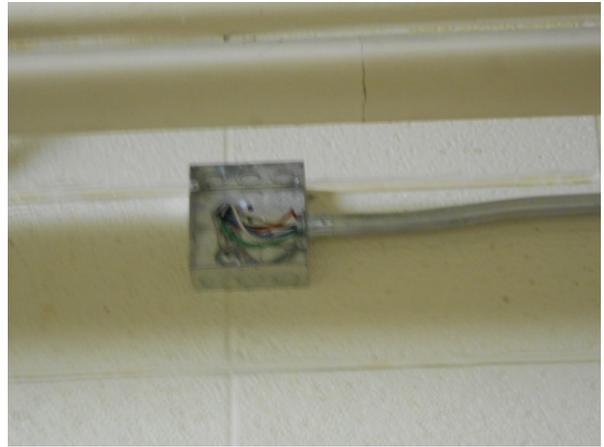
Photo #4

- Install all base molding as required.
- Install missing ceiling tiles.
- General touch up of paint.
- Install missing electrical plates. (See photo# 4)
- Label electric panel boxes and title each breaker inside to corresponding building locations.

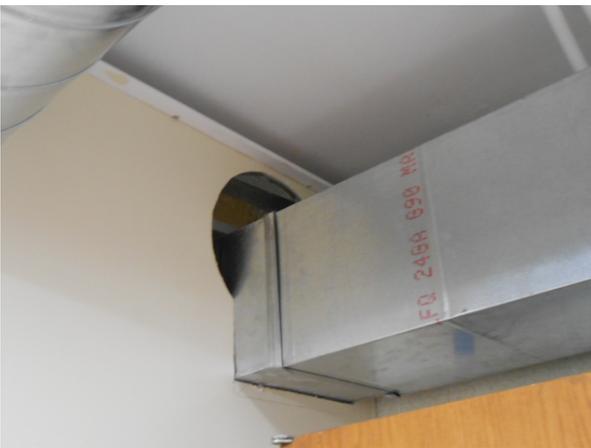
Photo #5

1. All rooms with spiral duct: Wall penetrations between classrooms at spiral duct work needs to be properly sealed and painted. (See photo#5).
 2. All rooms with spiral duct: Ceiling penetrations at ductwork needs to be properly sealed and painted. Also, notify roofer to correct areas where daylight can be seen at roof penetrations. (See photo# 6)
